PAGAN newsletter 1986

Conservation of Pagan monuments

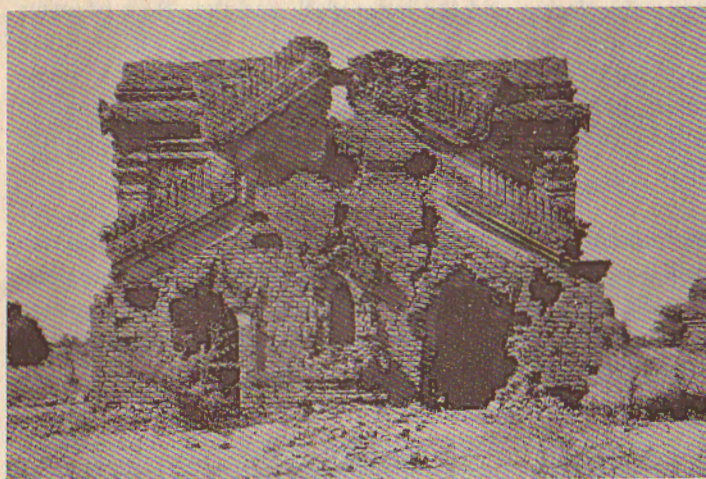
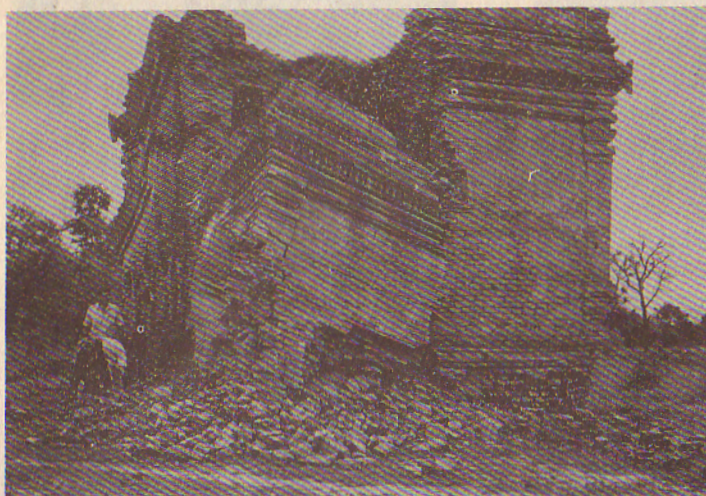
East face
December 1985

North view
August 1986

Monastery n° 525 near Minnanthu village, is a small rectangular structure (6.68×4.62 m outside) of the type most common in Pagan, with a central vaulted room and four doors, two on the main and eastern side and one on both the north and south sides, located near the east corners. At the north-east corner of the building, the base of the wall has been eroded for many years, and this whole corner collapsed on 10 August 1986 after two days of rain.

October 1983 when 18 cm of rainfall was recorded in only three days; then again in August 1986, after two days of rain, the corner of monastery n° 525 collapsed, exposing the inner core of walls and vaults and opening the way for its total destruction in the near future. All over Pagan, numerous brick mounds mark the location of former structures which have been totally erased by the same process.

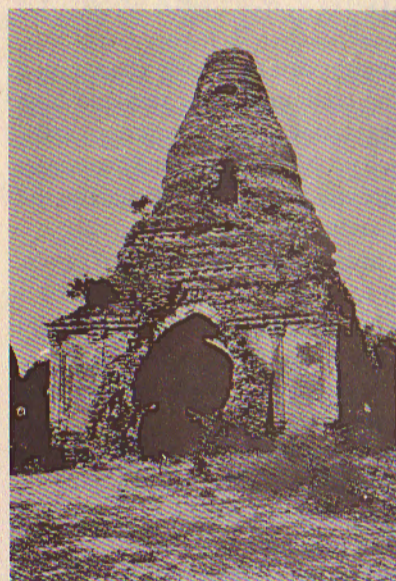
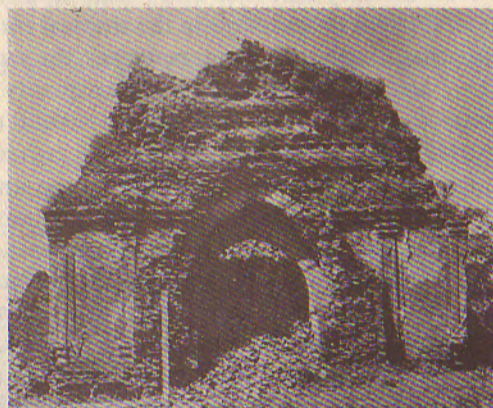
East face, 1975

Same view, 1983

After three days of heavy rainfall in October 1983, the vault of the central shrine of temple n° 1966, on the east side of Pagan village, caved in completely and its superstructures collapsed. This damage was the result of rainwater percolating into the unattended upper parts of the building, thus weakening and disintegrating the mortar in the brick vault.

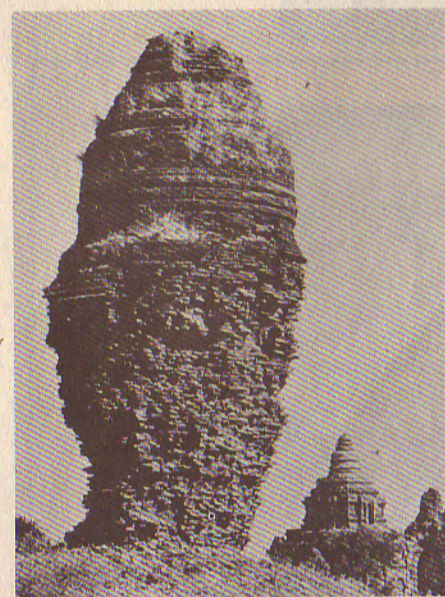
Stupa n° 428, December 1984, from south-west. The terraces which formed the base of the dome have been totally eroded by percolating rainwater. In this condition, the stupa withstood the 1975 earthquake, oscillating like a pendulum without structural disintegration.

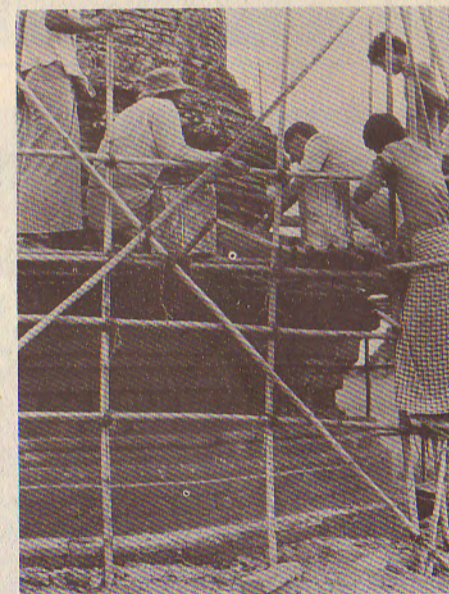
Stupa n° 581 north of Minnanthu, August 1986. Previously in the same condition as n° 428, its base is being reconstructed all around the monument. The same process was applied to n° 428 in 1985.

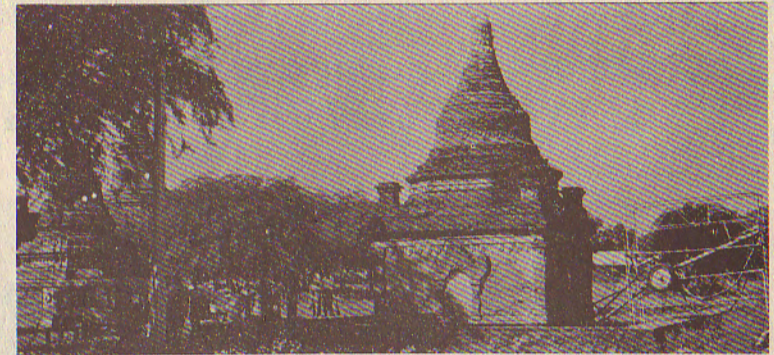
Temple no 1617, a late structure in the precincts of the Pagan Museum, has been selected for injection tests.

At the same time, specific equipment was provided to Pagan by the project for the actual implementation of strengthening methods recommended by the IZIIS team after their 1982 study of monuments (see *Pagan Newsletter* 1983). This equipment had first to be put in working order (which was not always as simple as it should have been, given the cursory nature of some manufacturers' notices . . .), then injection tests were carried out on a monument, using grouts of various compositions and proportions (lime, cement, brick powder, etc.). Before injecting, pointing of joints was completed to prevent leakage of grout through open joints and minor cracks.

The main difficulty came, once again, from the nature of the mortar: being clay, it is naturally waterproof and expands under humidity, thus preventing a deep penetration of grout. Other mixtures will be tried, with additives such as bentonite, for better penetration. Injection of chemical grouts, mainly silicates, will also be tested for improvement of the bearing and shearing capacities of mortar. However, there is little hope of significantly improving the mortar strength, and injections will be more systematically used around the inserted steel ties, to bind them to the masonries and to protect them from corrosion. These ties will eventually be the major method of helping the buildings to keep their structural integrity when subjected to disruptive seismic forces. They will be inserted in long bores drilled into the masonry at the most critical levels in order to form complete belts around the building. On a smaller scale, steel pins will be set into the masonries and sealed by injections in order to ensure the joining of the facing and core of brick walls.

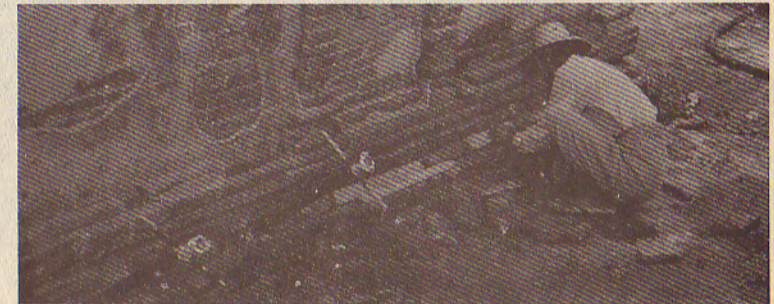
After the brick masonry has been pointed, injection packers are fixed in the drilled long bores.

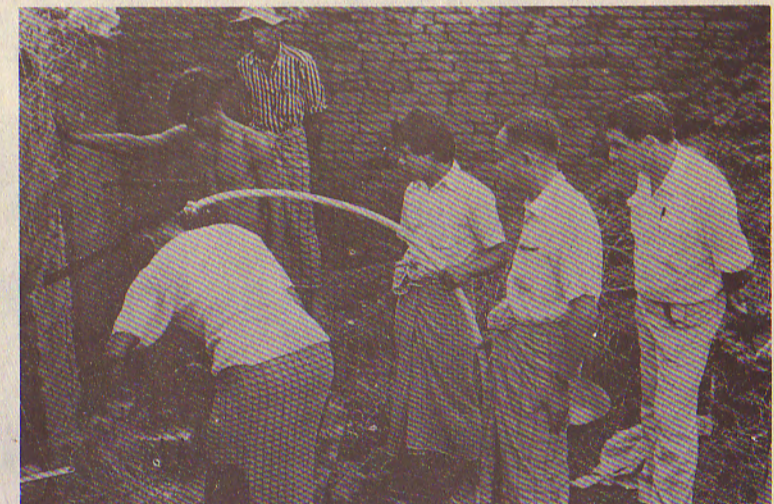
Various types of grouts are injected into the masonries.

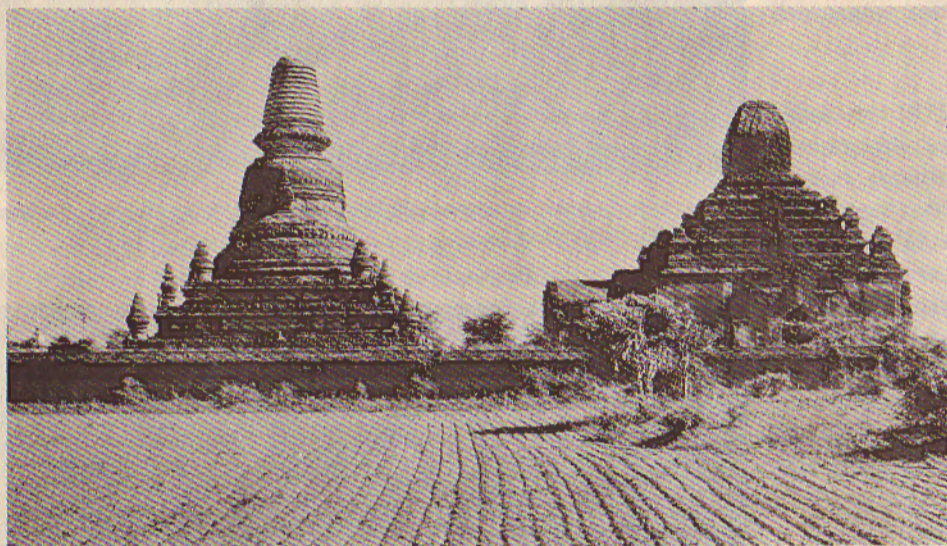
Seinnyet Nyima stupa 1086 and Seinnyet Ama temple 1085, from the north.

Not far from the river bank and 3 km south of Pagan, along the road to Thiripyitsaya, stand the two Seinnyet monuments: Seinnyet Ama temple 1085 and Seinnyet Nyima stupa 1086, both enclosed by one boundary wall and by an inner and lower wall around the central brick paved courtyard. The only entrance to the complex is on the west side, although the main access to the Seinnyet Ama temple is on its east side, where an entrance hall faces the stupa. The first close contact with the monuments is thus from behind.

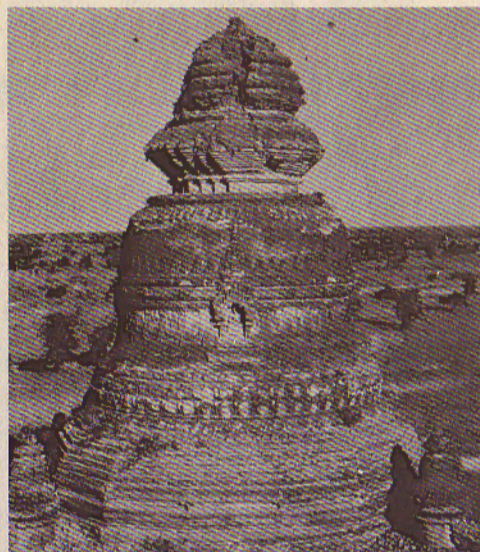
Upper parts of the stupa damaged by the 1975 earthquake.

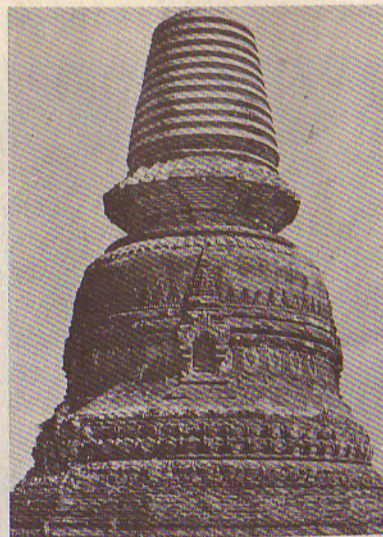
Same view, from the west: the spire was restored in 1977.

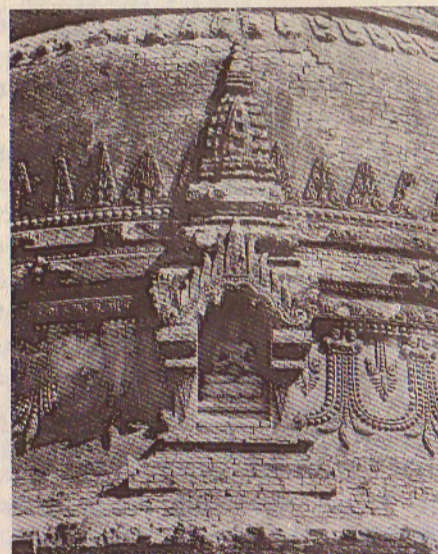
The western niche, half way up the bellshaped dome.

The Seinnyet Nyima stupa, on the eastern part of the courtyard, has three square terraces, with corners marked by small stupas of different shapes, and a fourth terrace, 16-sided. There is no stairway to give access to these terraces. Above, the bell shaped dome is topped by a moulded brick masonry block and a high conical spire. Such an upper block is the distinctive feature of numerous stupas which in Pagan are called "Singhalese type stupas". On its simplest form, for instance on Sittana stupa 987, it is in fact somewhat similar to the *hataras-kotuva* found on top of stupas in Sri Lanka, or to the *harmika* built on Indian and Nepalese stupas. On Seinnyet Nyima however, as on many other Pagan stupas, the shape is quite different and purely Burmese, with a strong cantilevered profile and a multi-recessed plan. This masonry block is often called the "relic chamber", not very accurately as the relics are generally concealed at the base of, or under, the dome. A special feature of Seinnyet Nyima is the niche, shaped like a typical Pagan temple with its porch and its square tower, sheltering a fine Buddha image on each of the four cardinal directions. There is no stone inscription to date these two monuments, whose style strongly suggests the second half of the 12th century AD. A former stupa, now encased in the masonry of the bellshaped dome, can be seen through a tunnel dug some time ago at the base of this dome.

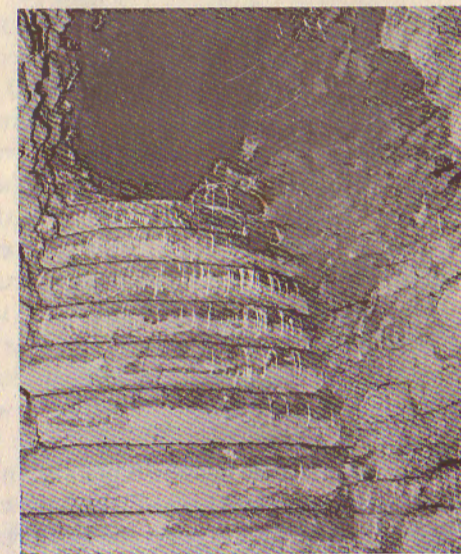
The top of the former stupa, now encased in the masonry of the 12th century dome.

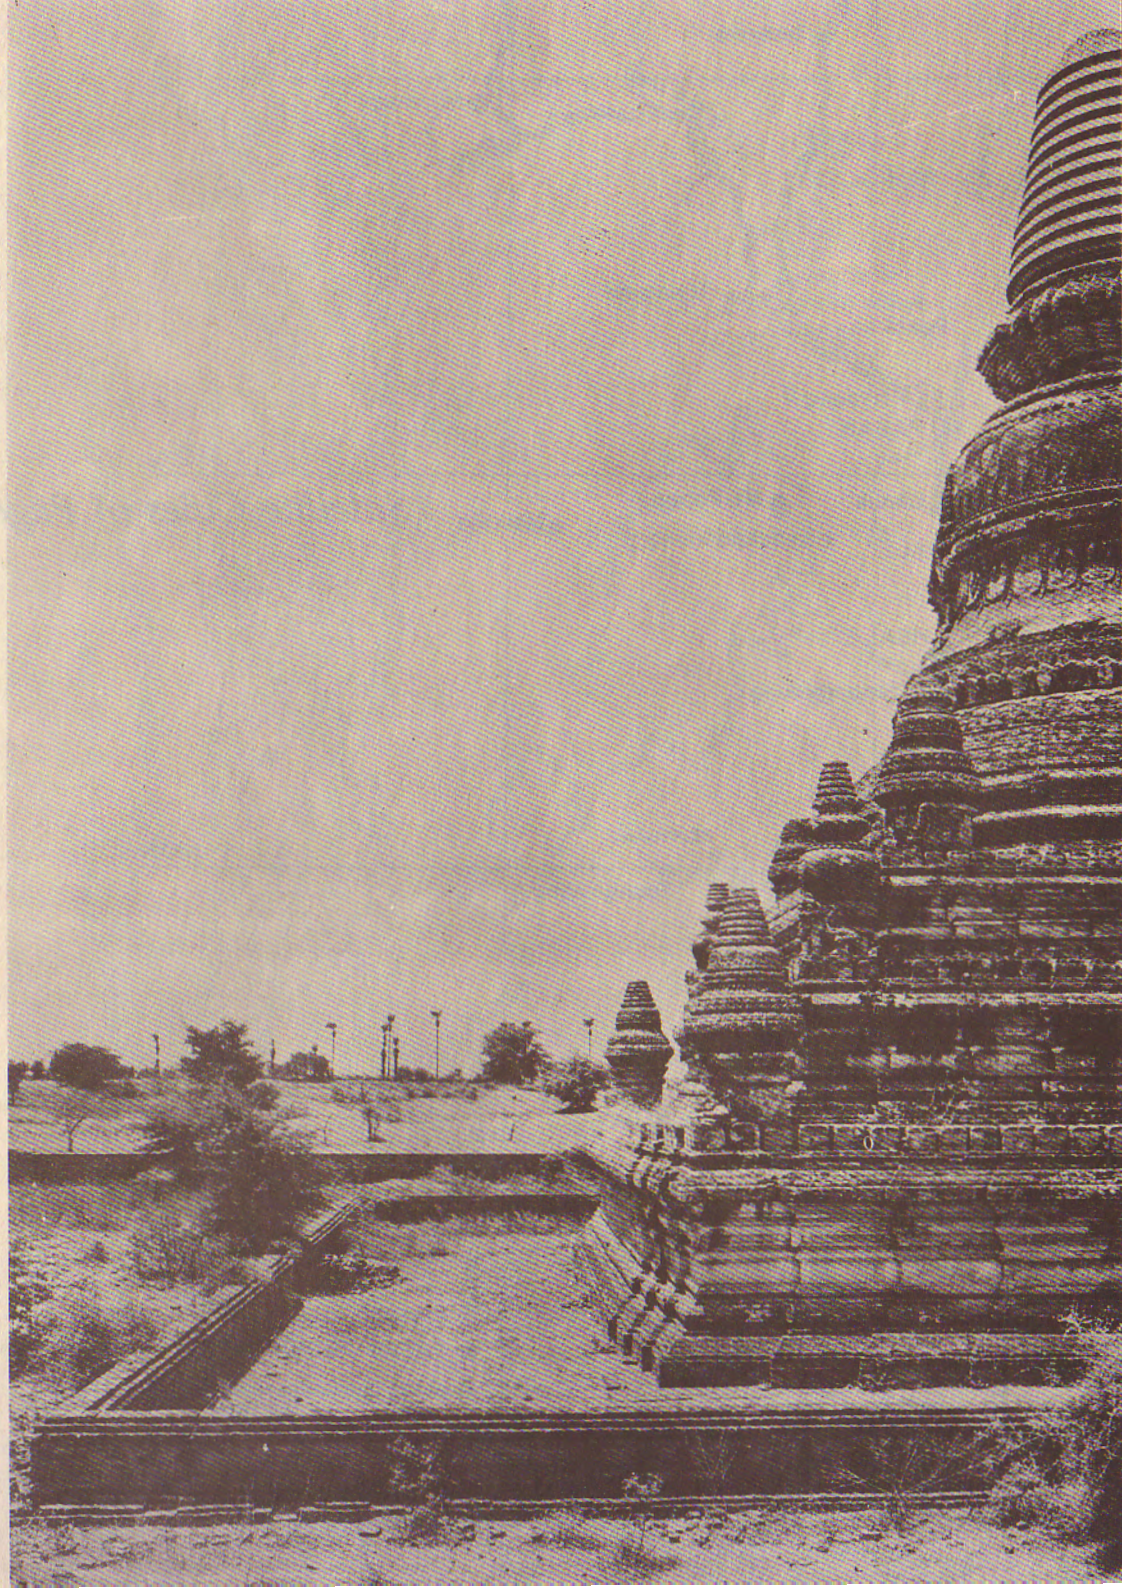
Seinnyet Nyima 1086: plan.

Seinnyet Ama 1085 and Seinnyet Nyima 1086: site plan.

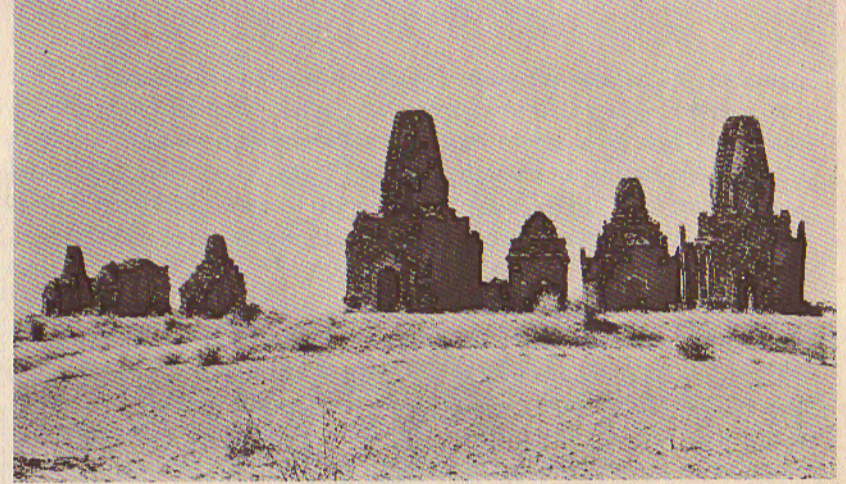
Hsalè: from right to left, temples n° 7, 8, 9, 10 and 13, 14, 15; from the east.

Though clearly designed on the Pagan model, the temples show special characteristics. There is no large temple as in Pagan, and all are of medium or small size, usually between 16 and 8 m long. They are based on the simplest type of Pagan temple: a square brick building with a vaulted central shrine, accessible only on one side

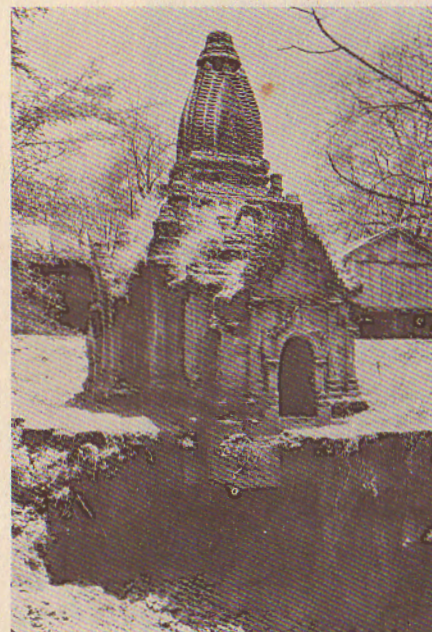
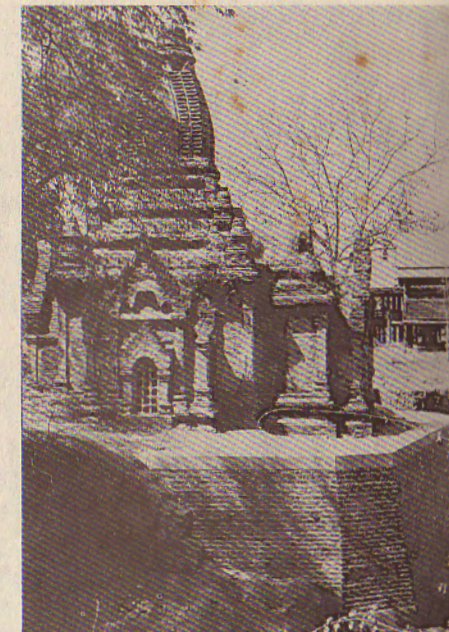
Salé, temple n° 86 threatened by total destruction from erosion of the bank of the stream (1981), and the brick embankment built to protect it in 1982.

Due to their remoteness, these sites are seldom inspected and attended by the Pagan branch of the Archaeology Department. Monuments are under the care of villagers, who inform the Department in case of danger or damage. An emergency brick embankment was built in 1982 to protect temple n° 86 in Salé against erosion by the nearby stream; repairs and pointing of masonry were carried out on Hsalè temples from 1968 to 1972. The 1975 earthquake, which caused so much damage to Pagan monuments, was also felt in Salé where temples n° 76 and 93 were completely destroyed.
